Description: Demolition of Buildings and Tree Removal at 602 South Evers St., Plant City, Florida.

**REPORT OF THE NESHAP DEMOLITION SURVEY, SAMPLING AND
EVALUATION OF ASBESTOS-CONTAINING MATERIALS**

**CHURCH PROPERTY
602 EVERS STREET
PLANT CITY, FLORIDA**

**September 7, 2016
GE Project Number 2648-0100**

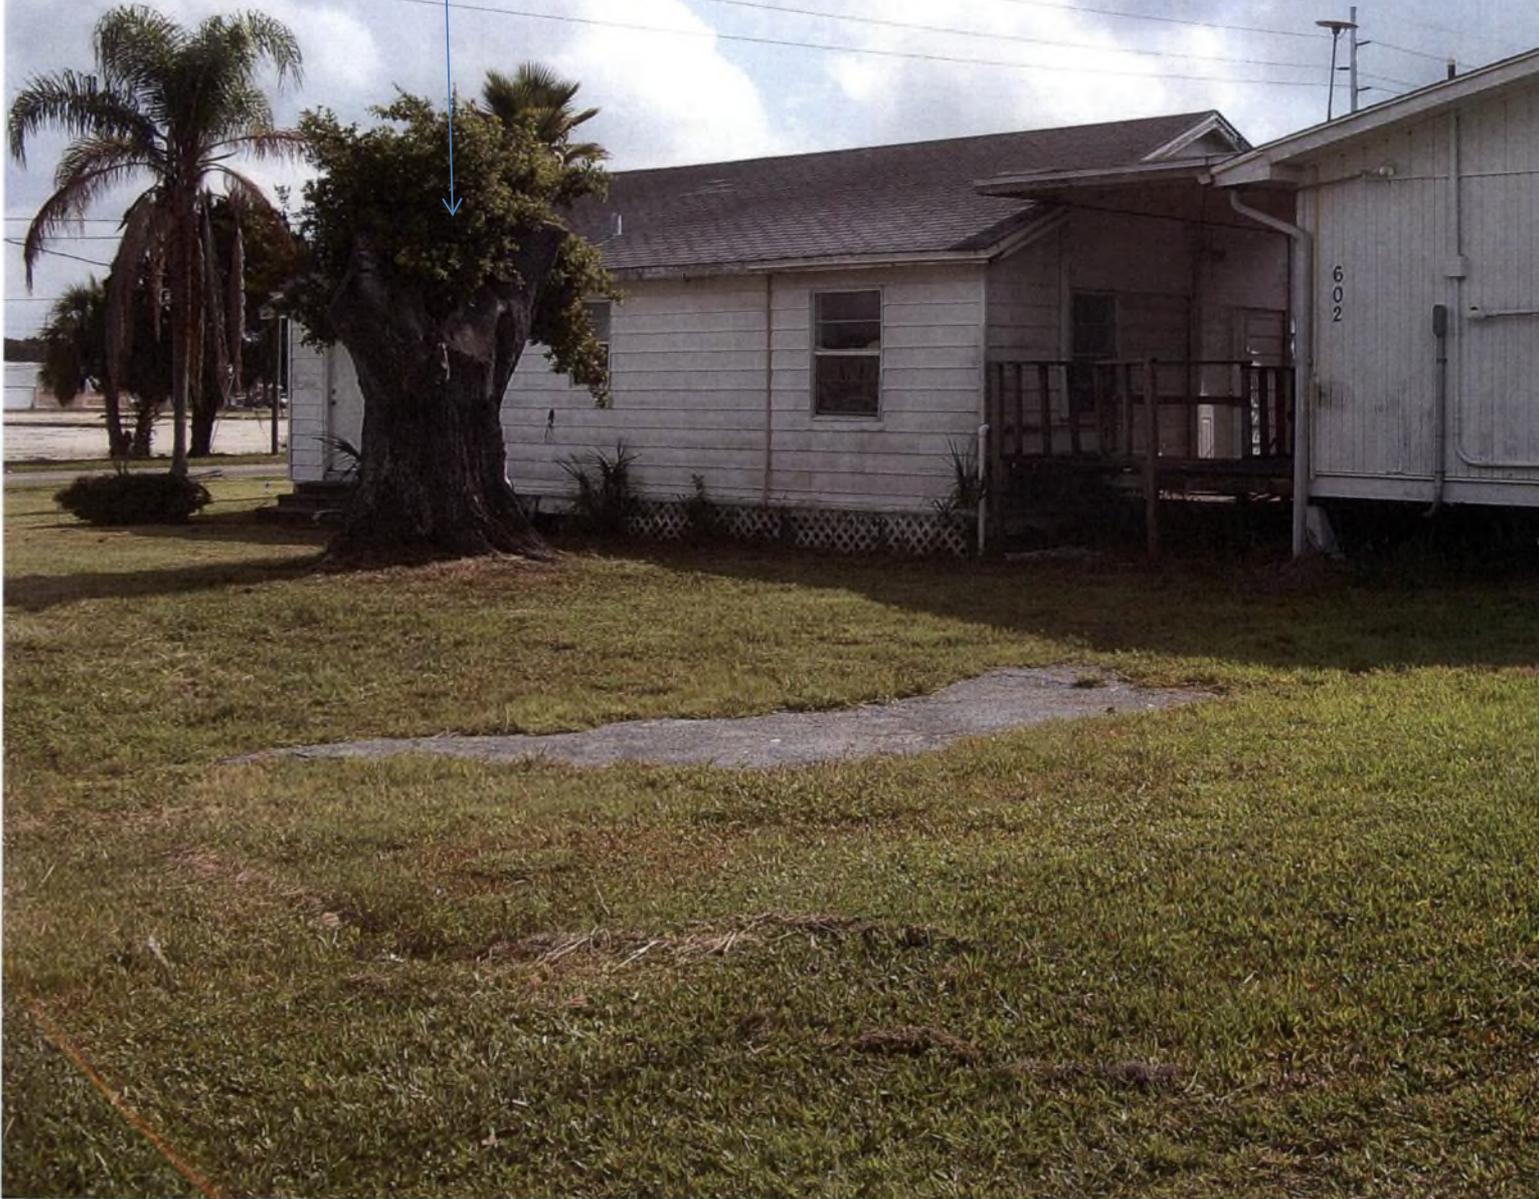
This tree is to be removed.

The tree adjacent to the old church building (shown on Exhibit A attached) shall be removed, including the stump, in such a fashion to leave a level dirt site. The contractor shall furnish any required fill dirt and the regrading of the site.
